Masterclass: Assessing Stonework

This edition's Masterclass looks at what you should be looking for when trying to assess whether or not a wall has faults. As a basis it uses the photo competition from *Stonechat* 15, Shirley Addy's Winning entry was as follows:

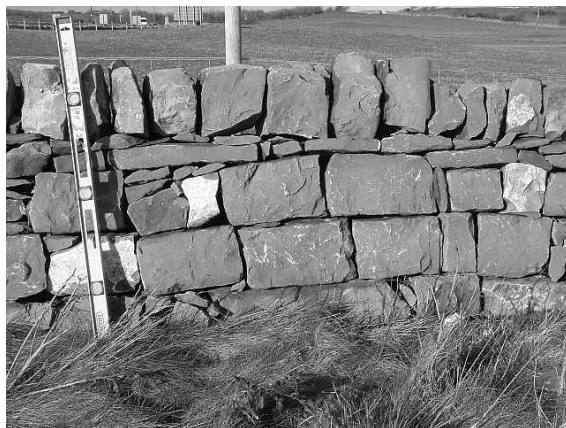
1. Copes very unevenly sized
2. Running joints – left and right of spirit level (and elsewhere).
3. Small stones at base (right of level).
4. Larger stones are being used above smaller ones

5. Several stones are placed vertically (white one right of level and third from right in second row)
6. Base of cope is too wide at 40cm relative to total height of wall (100cm.)

7. Fourth cope right of level not supported underneath hence gap, and should be placed on a horizontal side
8. Height of wall drops to right
9. Too many small stones at left of picture

10. Courses placed in wall too wavy: slopes downwards towards both sides of picture.
11. Too many gaps filled in with small stones at base especially 1st course right of level.

12. There does not appear to be any sloping batter in wall
13. Some copes are too large especially those in middle.
14. Unsightly gaps, such as at white 'thistle' stone right of spirit level.

15. Middle of base is overhung by second course
16. Largest stones should be at base
17. No throughs and appears to be built as brick wall.

Shirley's answer recognised the need for stone grading although I considered 3,4 and 16 to be tautological. It's possible that 4 related to some pinning (discussed below) but then this would have been the same as 11. I didn't feel it was possible to infer 15 from the photo and it wasn't actually the case. Only one entrant recognised the possibility that the large stones were set on edge.

The analysis above effectively deals with "length into wall". You can normally tell from the general dimensions of the wall and the relative visible dimensions of a stone whether many are traced, especially extreme examples. In the wall in question all 5 large stones are obviously traced, compounding the problem as where tracing is unavoidable it is best to avoid tracing stones next to each other, or on top of each other, as far as possible. In addition there is a very long traced stone immediately below the coping. This is not as serious as it would be lower in the wall since it has little weight acting on it, and it is tied by the coping.

This wall is riddled with 2 stone joints, not unusual with this type of stone where in effect every second course is levelled to avoid lots of thin levelling stones. This is in fact a common practice in Central and Southern Scotland, although not North Wales. Consequently it might not be a serious fault with this type of stone, however it implies subsequent good crossing of joints, and not having 2 stone joints every other stone! In an ideal world beyond sitting one stone on 2 and 2 on 1 you should aim for 1/2 on 1 and 1/2 on another. Crossing a whole series of joints by a centimetre or two doesn't give much strength to a wall and can create virtual running joints either vertically or diagonally. In addition

within this section of wall there are obvious running joints either side of the spirit level (ie joints of 3 or more stones vertically). A complete running joint as seen left takes an impressive degree of incompetence. With the 'competition wall', the running joints are only a stone apart exacerbating the fault. This is known as "stacking" and has no structural integrity, and is a particularly serious fault, as outlined in *Stonechat* 11's Rogues gallery (left).

See this edition's rogues gallery for more of an explanation. There are a number of pins under the lowest of the large stone (immediately to right of spirit level), more serious is a small pin under large central stone, even worse given it is traced and probably on edge.

Shirley's observation here is quite astute as the stone could have been ordered so much better. The reality is even starker as outside of the photo the stone size decreases quite considerably on either side.

One entrant referred to the vertical stones, i.e. essentially narrow stones stood upright to fill a gap between two large stones (2nd course up 3rd stone from right, and immediately above it fourth stone from right) as "soldiers" a term I had not previously come across, but will endeavour to use as standard in future. Whilst our North Welsh Cloddiau are essentially built from these "soldiers" that is once again a case specific regional variation with its own technical niceties. Within dry stone walling it is a practice that is generally frowned upon. I'm not entirely convinced as to how bad a practice it is IF the stone is the right height and a very tight fit. There are however considerations with stone type (grain), and frequency - twice in a few square centimetres should be excessive by anyone's definition. I will admit to doing it, but generally only on farm walls and literally once or twice a year, not every half hour! Generally it can be easily avoided just by ordering the stone better, and just points to bad technique. Here the builder cannot even argue it facilitates better crossing of joints given that it actually creates them.

As to Shirley's answers; point 13 is essentially just explaining/expanding 1, which is of course in itself correct. Point 6 is not strictly true, or only if a strict formula for wall dimensions is applied without recourse to stone type or local tradition, which in both instances would be more likely to point to this wall being on the narrow side. So all things considered it isn't a silly width given that it needs to be wide enough to facilitate building stone size whilst trying to be narrow enough to cope with a single stone. Point 7 is probably mostly correct. It could be a stone with a bit missing, assuming it isn't then it should not be set on this surface, as to whether or not it should be set horizontally is a whole different ball game as it would then be lower than everything else.

Shirley specifically mentions this so I better had. The overall height does vary, but it is more notable as a problem with coping than the height *per se*. The height of the stonework below the coping might vary marginally, but difficult to tell from the photo given the grass.

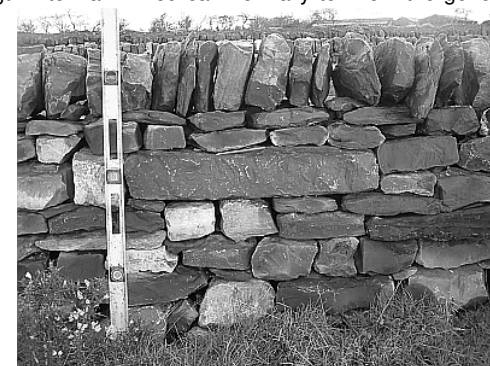
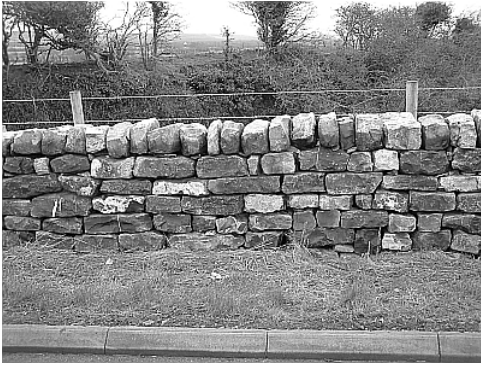
Single 'excessively' traced stone.
A5/A55 Anglesey © S.Adcock

However it is more serious than it would otherwise be given the prevalence of other traced stones.

Left: Section of wall where most of the stones are traced. A5/A55 Anglesey. © S.Adcock

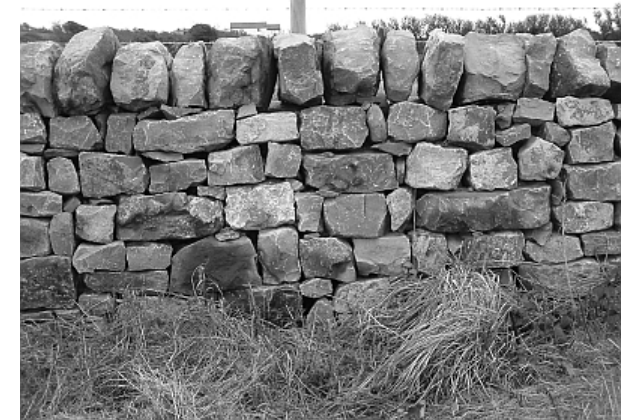
Complete running joint (centre). A5/A55 Anglesey

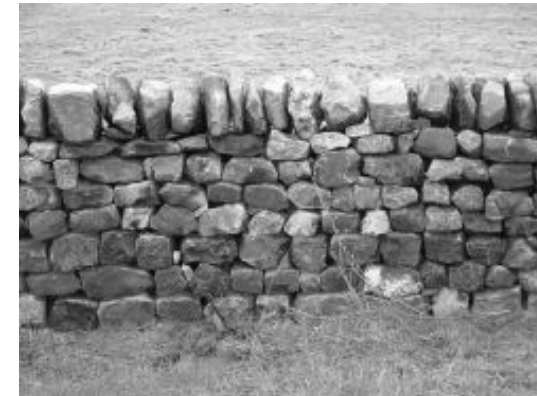
"Stacking". A5/A55 Anglesey

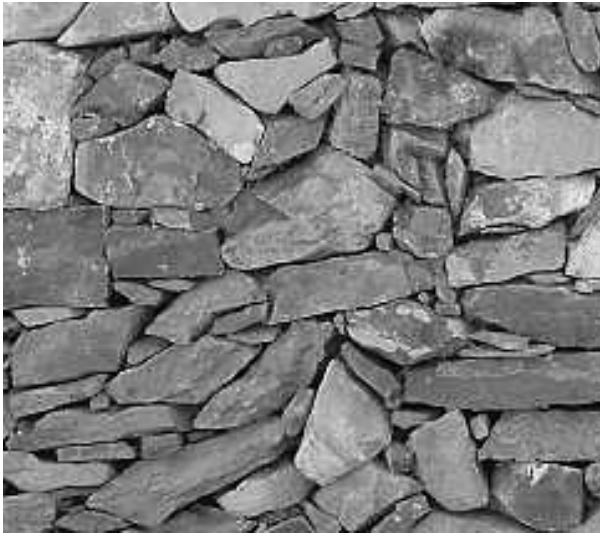
Ty'n y Fynnon, Betws yn Rhos

Shirley was correct in noting that the coursing bent down at the end. It is a fault but perhaps not that severe, this criticism relates more to this extract from the wall featured in *Stonechat* 14's Rogues gallery. If it wasn't within a 'normal' layered wall this could almost pass for polygonal walling! It can of course also apply to where a whole layer or course slopes either down or up (depends which way you're looking at it I suppose and what it is doing relative to the actual slope of the ground)
