Beautiful, but how long will they last?

MANY STONE WALLS BUILT SHODDILY

By SEAN ADCOCK
Daily Post contributor

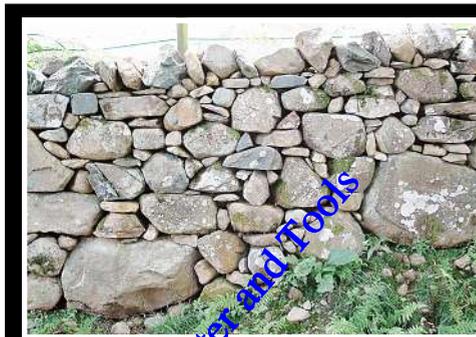
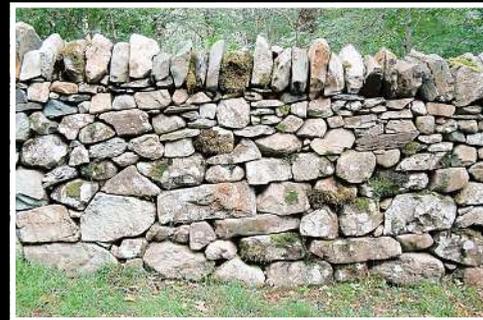
Sections from the same wall. On the left, large stones have placed almost 'willy-nilly' and gaps filled with smaller stones – a faster but far less solid approach. On the right, a well-built wall, with large stones fitted in the bottom, producing an arguably more pleasing finish

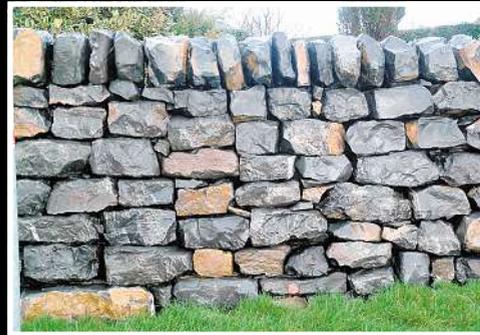
Some times, however, stones are "stacked", with running joints on either side of a series of stones.

This should be an obvious fault but was commonplace on the new walls built on the A55 dualling, side roads which link it to the old A5.

It seems likely that those inspecting the work were unaware of the problem. Many sections of these walls have since failed and are now being repaired with mortar.

Long running joints are a major weakness in dry stone walls, as shown here.

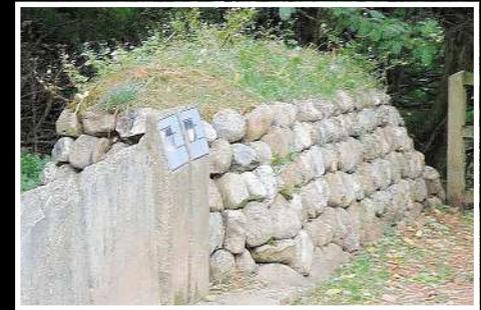
The importance of clawdd walls is such that it represents North Wales in the "Millennium Wall" at the National Stone Centre, Derbyshire
