Britain & Ireland's Walling Treasures: North Wales Slate Industry

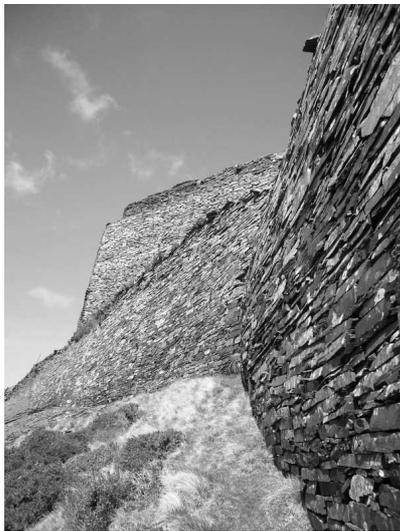
This tiered retaining wall is the “Australia Terrace” located high up in Dinorwic. Clearly visible from the A4086 alongside Llyn Peris over a mile away, a crude estimate suggests it is over 12m high. Constructed to create a large working area dominated by the ‘Australia Mill’, over 100m long and still populated by its 36 rusting circular saw tables (in use until 1969). At the other end of Dinorwic in the Vivian Quarry, (just behind the National Slate Museum), is another impressive retaining wall terrace built around 1880. It has a stepped profile and at its maximum it is almost the same height as Australia although not as long.

The terrace again creates a working area, with a series of hand trimming and dressing sheds. Remains of these sheds known as *waliau* (singular *wal*), can be found on many of the old quarry sites. They are so named because they were originally a simple wall offering limited protection from the elements, side walls were a major advance and roofs the ultimate luxury.

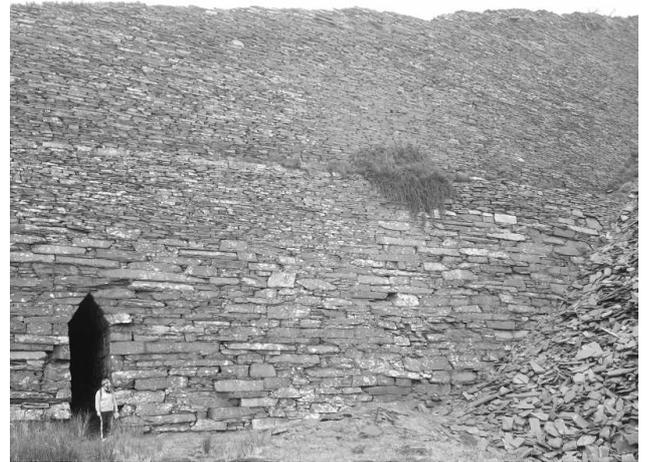
Dinorwic has several sets of inclines. The one below is part of the ‘A series’. Waste tipping now means it is a retaining wall, the impressive ‘tunnel’ going nowhere.

It is difficult to know how to measure these inclines as they merge with the slate heaps - this one I would guess is at least 11m high, at the merger point.

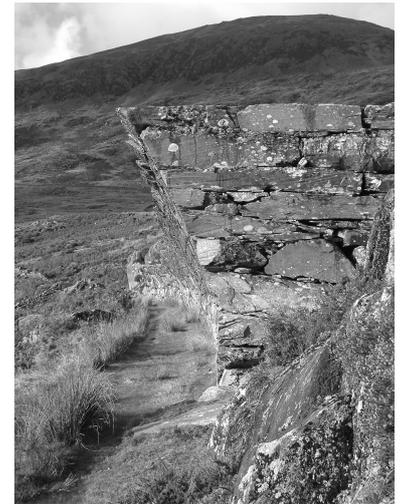
Disposing of Slate waste was a perennial problem at many quarries. In Gorseddau, Cwm Ystraddlyn near Porthmadog, it led to the creation of the famous overhanging wall. Built around 1860 it is just under 100m long and almost exactly 4m high. The top overhangs the base by 1.5m. Situated at the base of a waste heap it protected the exit tramway from waste heap spillage. Ground conditions and lack of space suggest its construction was a more viable alternative than moving the tramway.

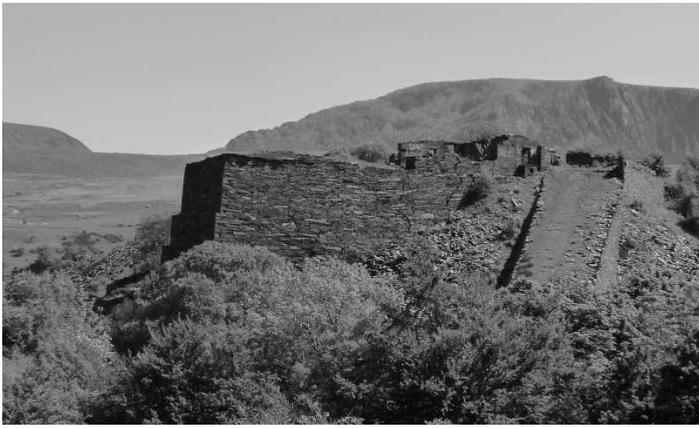
Dorothea has two of these huge structures each combining inclines, and loading platforms/work areas. Pyramid C (it served quarry area C) is relatively modern, having been completed in 1913 and operational for only about 30 years, was built on top of an older 1880s incline (another can still be seen in the photo below). The end is over 11m high and supported the headgear for

an aerial incline/ropeway into the pit below (out of picture left). Much of the blocky and angular slate used (flatter slate is favoured for most structures), is cracking and faults developing. Pyramid “B” was constructed from flatter slate (1880s) and has experienced a couple of major eruptions of its faces. Unlike “C” it was originally built independent of any other structure and its face was lime mortared, which I suspect might be at the root of its problems as much of the mortar has weathered away. Both are grade II listed buildings although here have been moves to demolish them from developers and officials - on Health and Safety grounds, whilst archive photos of Pyramid B suggest it has not deteriorated much in 30 years it is certain that neither will spontaneously recover.

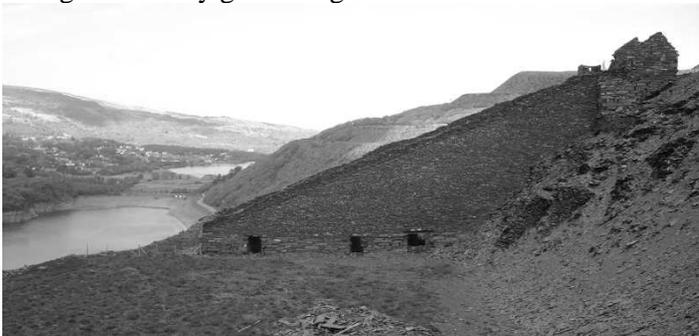
This incline C3, (C1 has gone, C2 is equally spectacular and truncated) is at least 10m above ground at its highest point, but the level of the winding house is in region of 15-16m above relative ground level.

General decay is not the only problem facing quarry structures. Back in Dinorwic the lower sections of both the B and C series inclines have been lost to a pump storage electricity generating scheme.

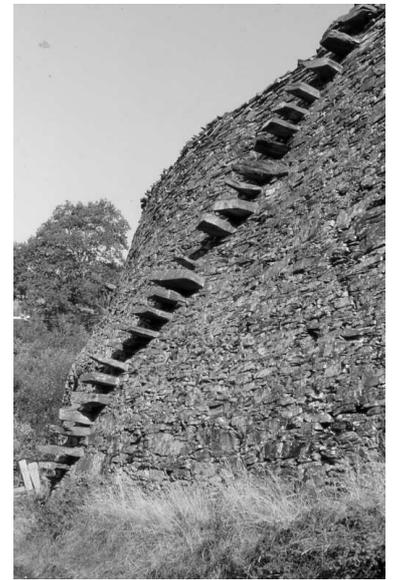
In the late 1980s I was staying in Corris on a contract when I saw an archive photo of these steps in use. I thought 'I must go and see if I can find those'. Ever since, every few years when I've passed Corris, I've thought 'I really must get around to seeing those steps'. In the late 1990s the steps were landscaped. What you never had, you never missed... I don't think so. I'm indebted to Alun John Richards for this photo.

The other “mega-quarry”, Penrhyn, had many similar structures to Dinorwic. However it continues in production and the practice of mass bulk working and creation of roadways has destroyed a great deal, bringing me to what is perhaps the whole *raison d’être* of this series. I doubt that any of us knows or truly appreciates the whole range of stone structures big and small around us, and nothing lasts forever. Who knows what we have lost before anyone bothered to tell us it existed? For me this is encapsulated by the remarkable cantilevered steps in a retaining wall at Abercwmeiddaw, Corris near Machynlleth.
