From the wailing wall to the pyramids: An overview of the dry stone structures of the North Wales Slate Industry.

Sean Adcock

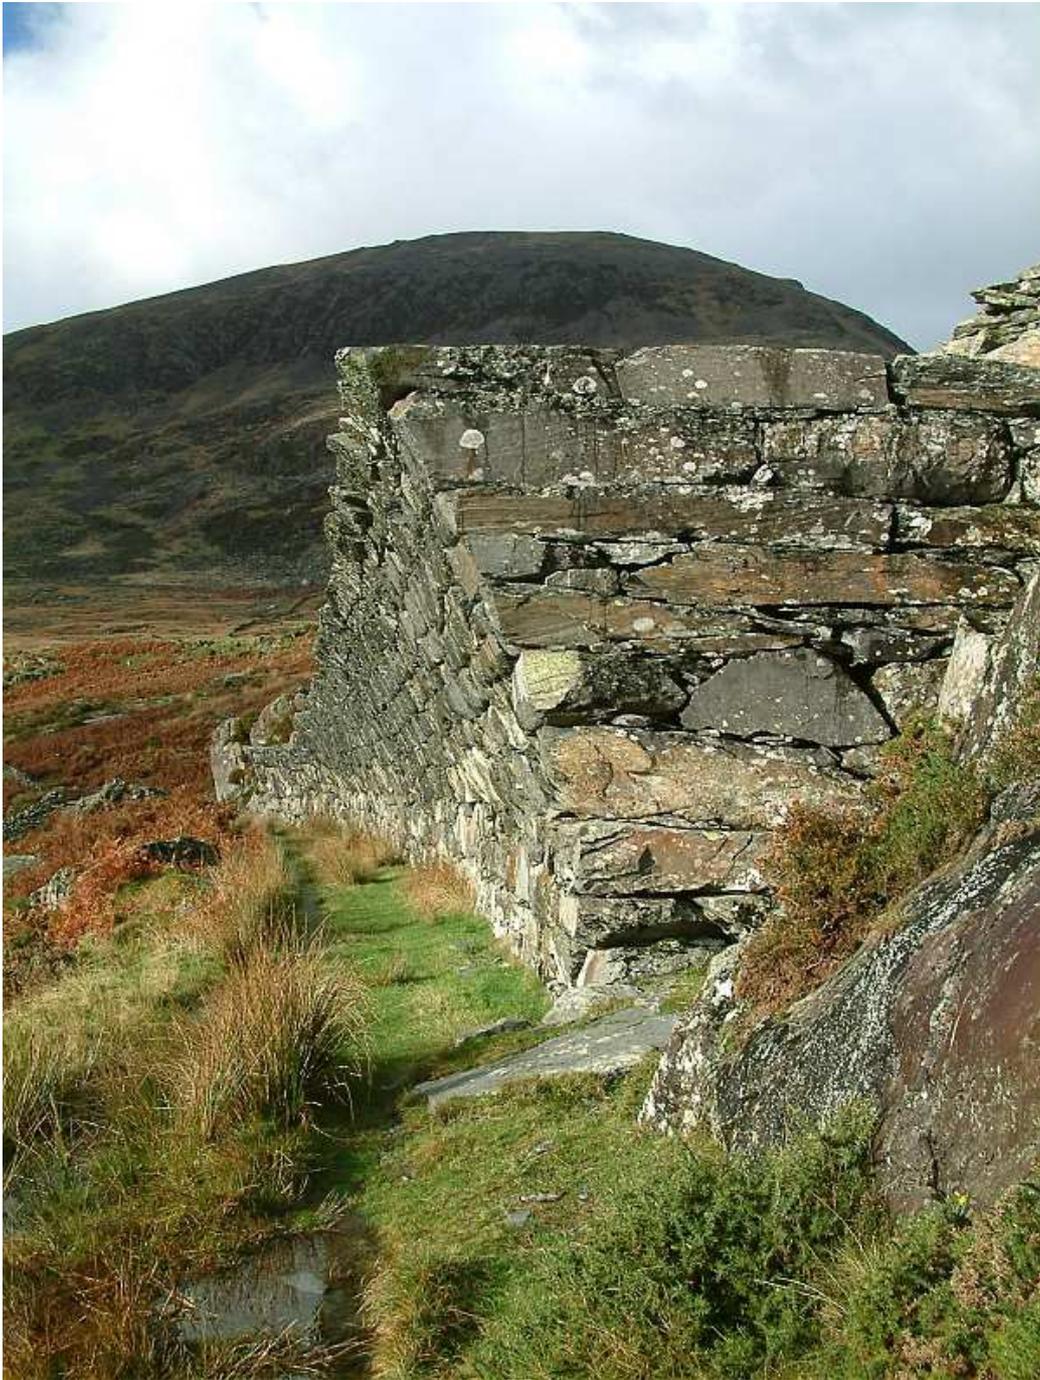
As elsewhere Dinorwic has its share of retaining walls, in its case on the grand scale. The "Australia Terrace" located high up in the quarry is clearly visible from the road alongside Llyn Peris almost 2 kilometres away, a rough estimate suggests it is over 12 metres high.

Constructed to create a large working area dominated by the lime mortared 'Australia Mill', which still stands over 100 metres long, roofless but still populated by its 36 rusting circular saw tables (in use until 1969). At the other end of Dinorwic in the attached Vivian Quarry, (just behind the Welsh National Slate Museum), there are a number of impressive retaining walls, each eking out a few square metres of work space from a vertiginous hillside. The most impressive of these has a stepped profile, built around 1880 it reaches to a height similar to 'Australia' although not as long it remains an

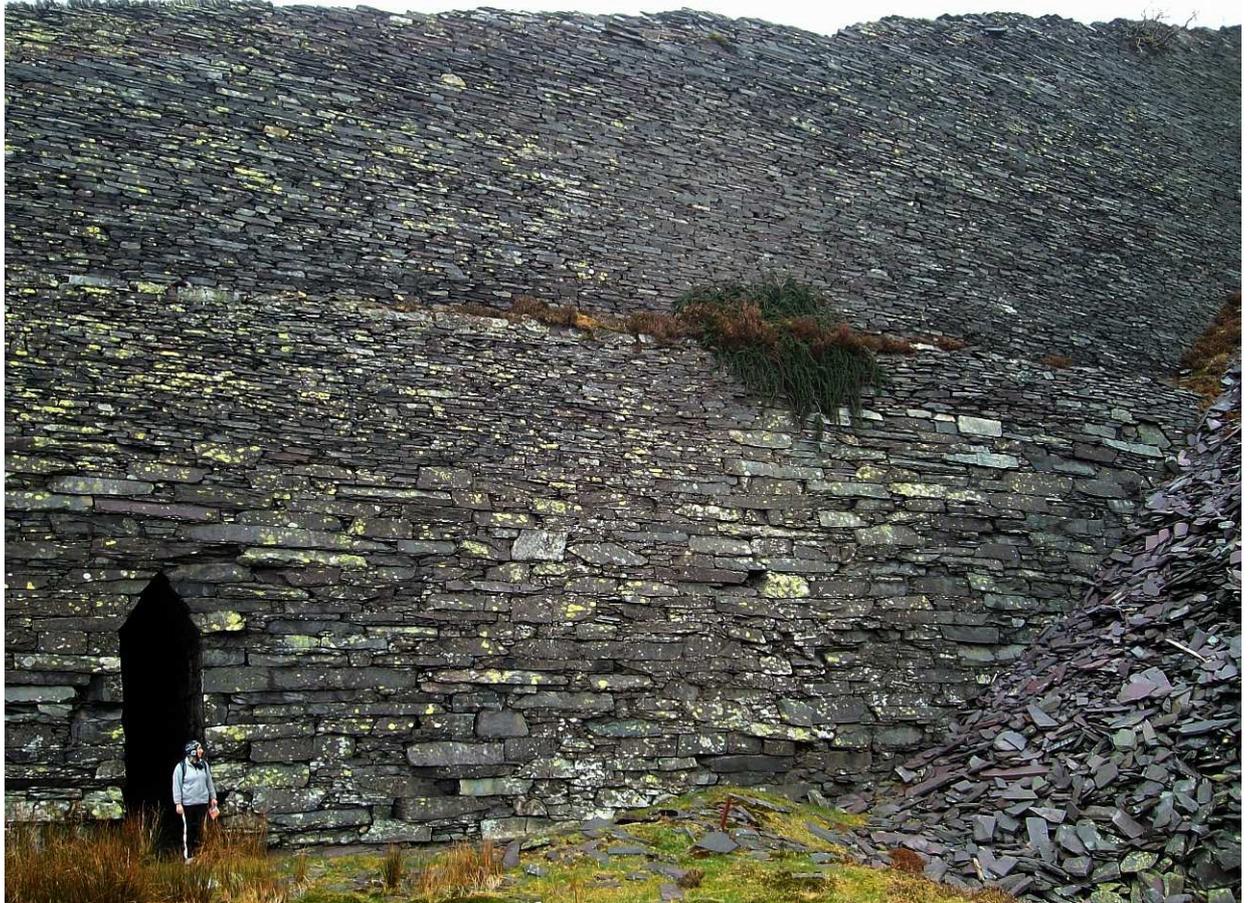
Dorothea has two of these huge structures each combining inclines, and loading platforms/work areas and originally supporting the headgear for an aerial incline/ropeway into the pit below. Pyramid C (it served quarry area C) is relatively modern, completed in 1913 it operated only for about 30 years. Built on top of an older 1880s incline it abuts another, its end towering to around 11 metres (nearer 15 when adding the tiered retaining walls immediately below). Much of the blocky and angular slate used (flatter slate is favoured for most structures), is cracking and faults are developing. It seems likely that its relatively modern construction meant that only poorer waste material was used for its construction, perhaps the better quality material was seen as too valuable. Pyramid “B” is older (1880s) and constructed from flatter lime mortared slate. It has experienced a couple of major eruptions of its faces, perhaps the degradation of the lime mortar in such a

vast structure has destabilised it compared to pure dry stone.

Many of the more impressive structures have some form of legal protection, some of the smaller ones because they are part of some wider designation protecting an area. The Dorothea pyramids are independently Scheduled Ancient Monuments of at least National importance, and arguably of World significance. They are aging, crumbling structures in an area with wide public access, both immediately adjacent to footpaths. As a result there have been moves from those with development interests and even council officials to demolish them on safety grounds. So far these have failed however they will not spontaneously recover and in the absence of any likelihood of remedial work it seems inevitable that one day they will be demolished, unless they collapse first.
